## IMMEDIATE ACTION REQUIRED BULLETIN

**Equipment:** Endura Controller

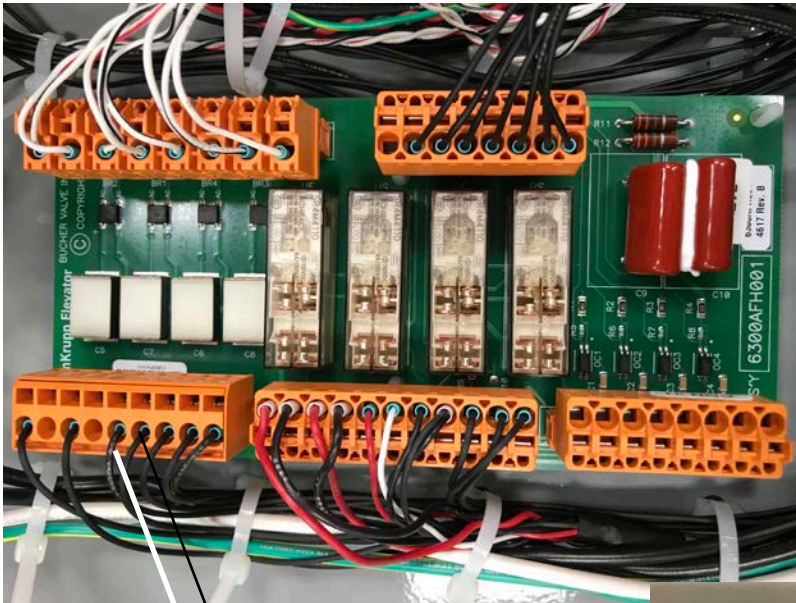
**Problem:** Wiring error on the bucher power supply harness (Con 1 pin 3 on 6300AFH board). While on inspection the car could move at near 70 FPM in the down direction. Reference Gensuite #20126.

**Solution:** Inspect that CON1 Pin 6 is connected to Pin 4 on the bucher power supply. Correct if mis-wired.

Confirm CON1 Pin 6 is connected Pin 4 on power supply.
