# IUEC INCIDENT SUMMARY

CLOSE CALLS, NEAR MISSES AND INJURIES

# Incident Report

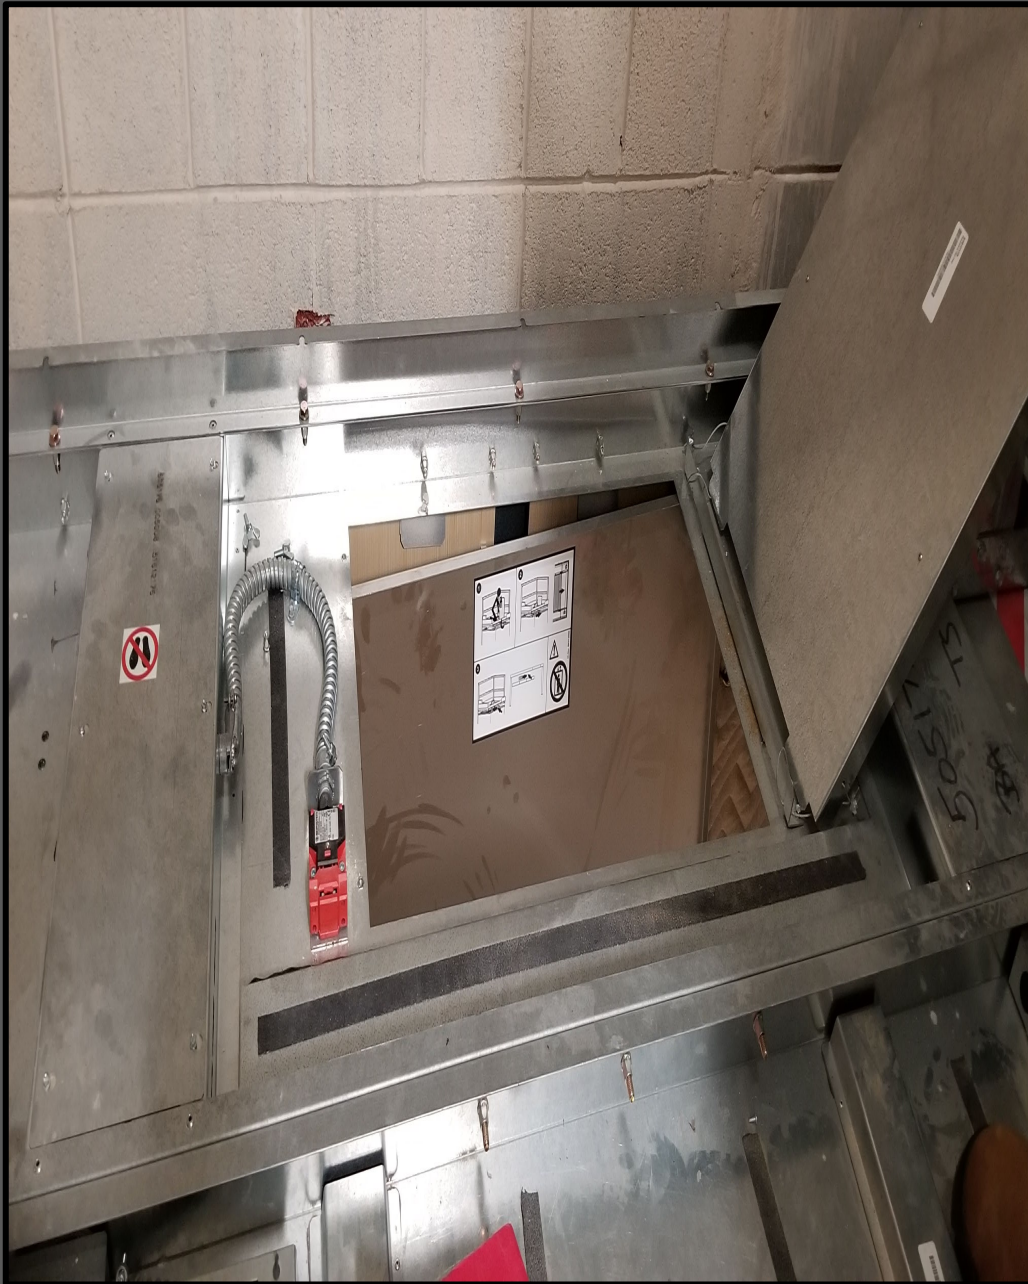
- A service mechanic received a call for an elevator shutdown. Upon arrival he suspected the car had a bad drive.
- The mechanic entered the car top at the 2<sup>nd</sup> floor, followed all safety procedures, and removed the car top escape hatch panel. Next, he tried to remove the ceiling panel to install a ladder so he could get out of the hoistway if necessary.
- The first mechanic called another mechanic for assistance. They discussed the procedures they were going to use to gain access to the car by removing the ceiling panel.
- They still could not remove the ceiling panel. One of the mechanics inadvertently stepped on the ceiling panel, which gave way, and he fell to the back of the hoistway dislocating his shoulder.
- After having his shoulder reset, he is home healing for 4 weeks.

- Always follow the company safety policy
- Always perform a JHA/JSA per company policy
- Always follow the MCP (maintenance control plan)
- Possible root causes:
  - There was no SOP available for this work
  - Poor walking/working surfaces
  - When the escape hatch is open, the ceiling panel looks the same as the car top
  - No warning labels were applied: “Do Not Stand Here”
- FESHB Section 4 Fall protection
  - General Requirements
  - Fall protection is required when a worker is exposed to a fall hazard (working more than 6 ft. (1.8 m) above a lower level and an opening more than 12 in. by 12 in. (305 mm by 305mm) and the work activity is within 6ft of the opening.
