# IUEC INCIDENT SUMMARY

CLOSE CALLS & INJURIES

INJURY

AUGUST 6, 2024

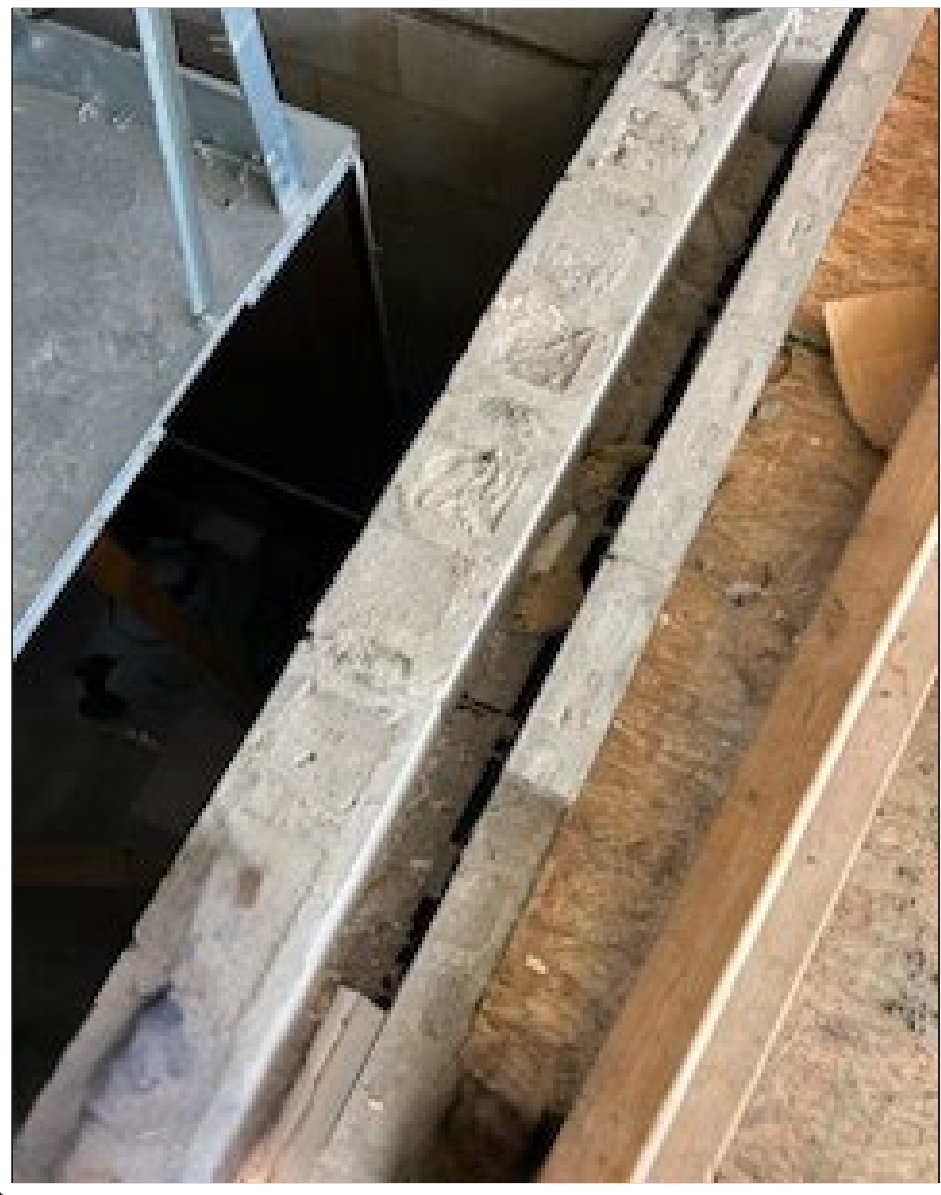
- 
- A construction crew arrived at a jobsite and informed the General Contractor the expansion joint on the top floor needed to be filled before work could begin. Their supervisor had previously informed the contractor the hazard must be corrected as well.
  - The contractor asked the crew to get started with the hazard unprotected. The crew proceeded to work because they didn't want to fall behind
  - A couple of days into the installation, while stepping from the car top to the landing, the mechanic's boot got caught in the expansion joint causing him to fall and break his Tibia

The mechanic will miss 6-8 weeks of work while recovering from a broken Tibia

- Failure to correct an identified hazard
- Not avoiding the hazard until it is removed

- Always follow the company safety policy
- Always perform a JHA/JSA as per company policy

(d) When it is the responsibility of others to correct unsafe conditions, notify those responsible, (i.e., Building Owner, Project Manager, General Contractor) verbally and/or in writing per company policy. Also notify your Superintendent/Manager that such unsafe conditions exist. Avoid the area until hazard(s) is removed.
