IUEC INCIDENT SUMMARY

CLOSE CALLS & INJURIES

INJURY

SEPTEMBER 3, 2024

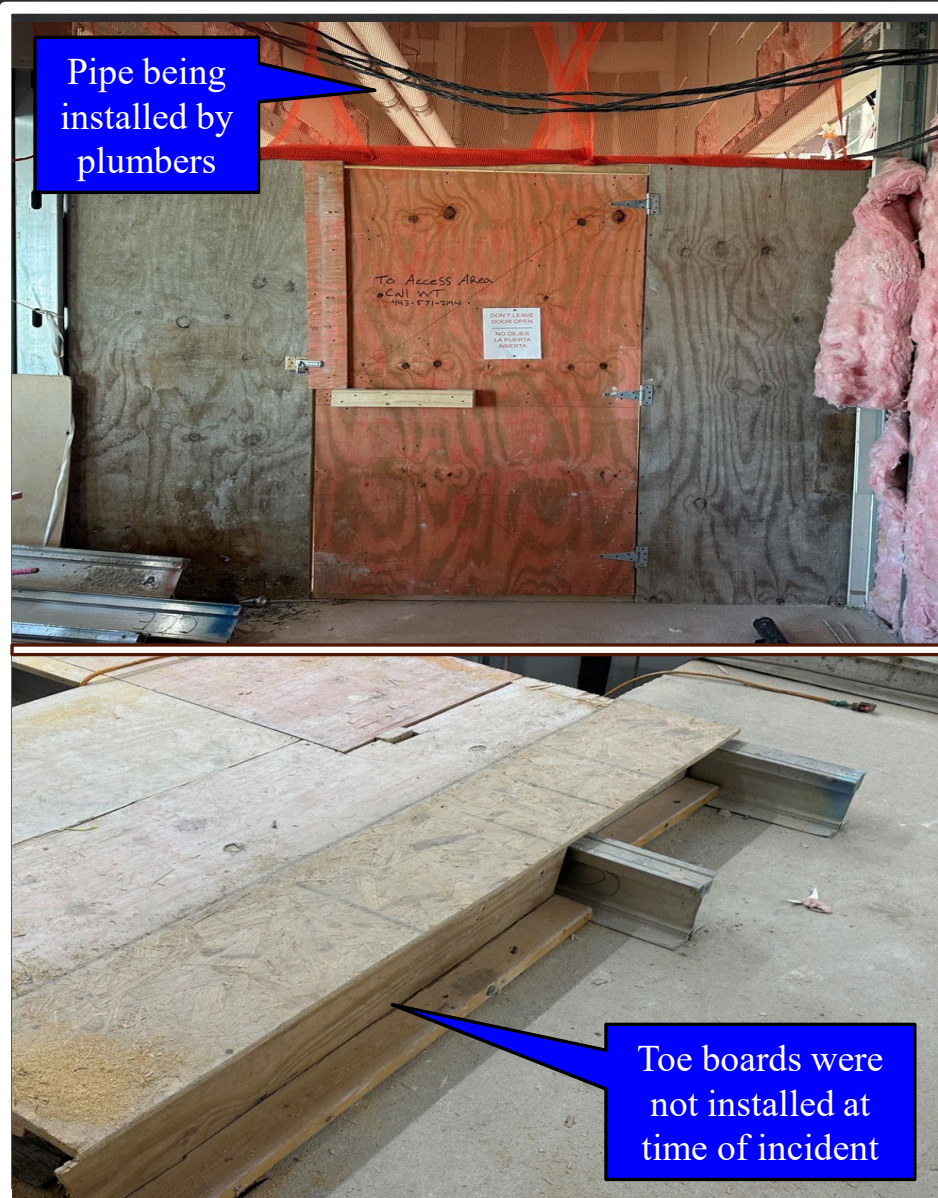
- A construction crew was working in the pit installing rail brackets and the first set of guide rails
- Plumbers were working in the lobby area of the top landing and accidentally kicked a piece of pipe down the hoistway, striking the temporary mechanic in the face
- The top floor lobby had a lockable door and decking for overhead protection but lacked a toe guard at floor level

- Lack of communication between General Contractor and other trades
- Unguarded holes in overhead protection
- Stacked work

- Always follow the company safety policy
- Always perform a JHA/JSA as per company policy
- Always notify the General Contractor and other trades when arriving on site and beginning work in the hoistway

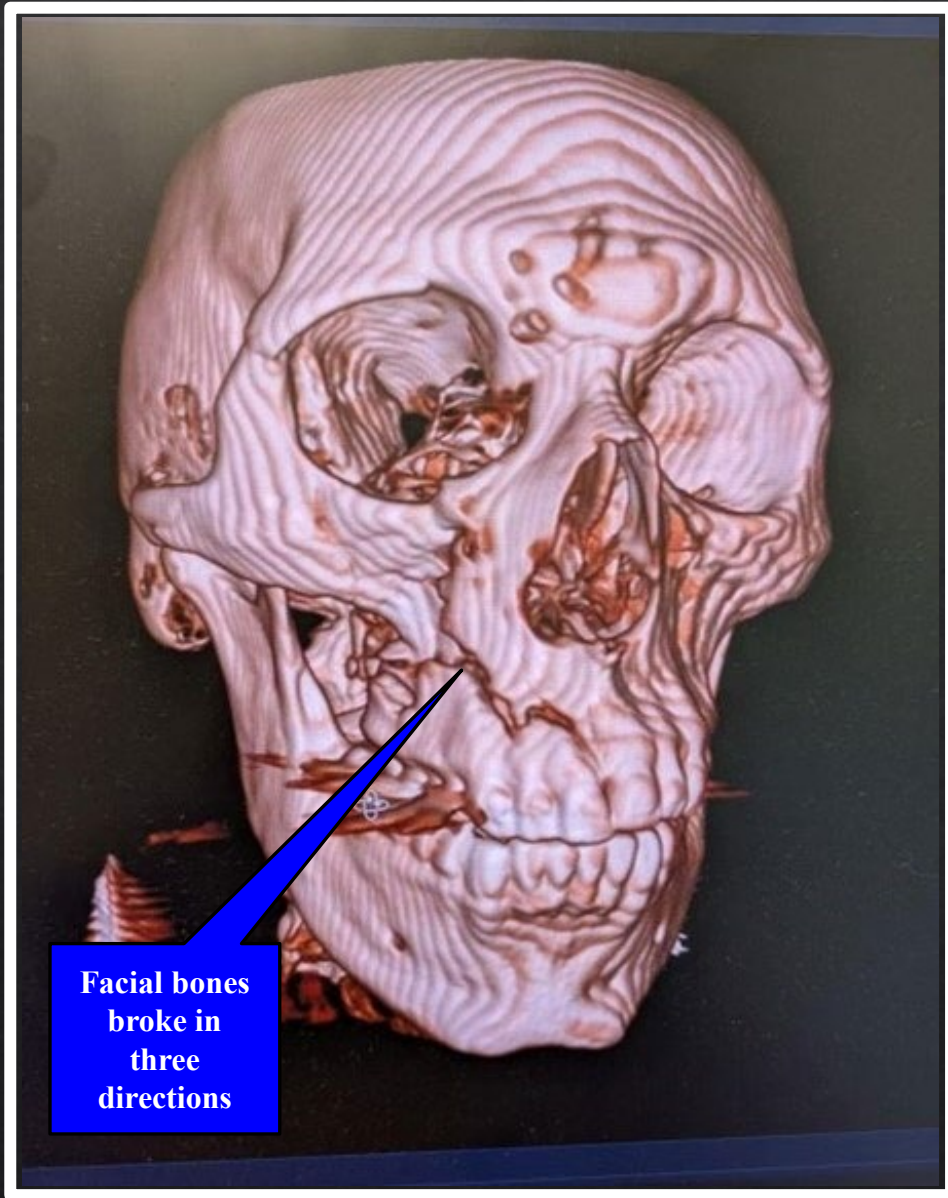
The TM suffered multiple broken bones in his face and had two metal plates installed to support the broken bones. He will be out of work for 4-6 additional weeks while in recovery and for further evaluation.

Facial bones
broke in
three
directions
