# IUEC INCIDENT SUMMARY

CLOSE CALLS & INJURIES

**INJURY**

SEPTEMBER 4, 2024

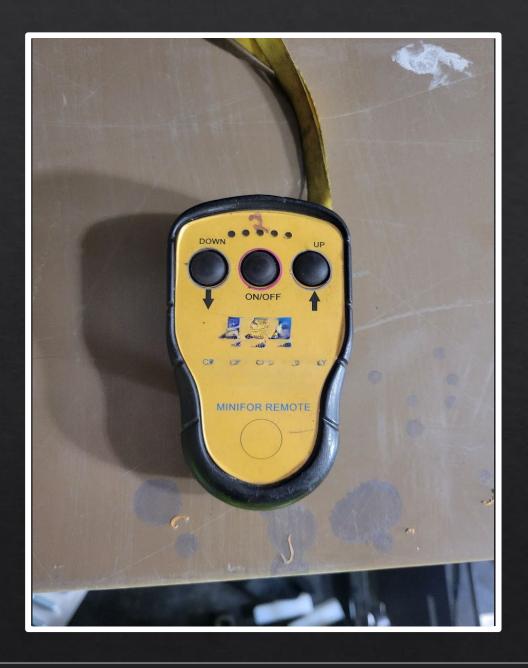
- As they were hoisting the car platform into the hoistway, communications between the wireless remote and the electric hoist were lost
- The apprentice repositioned himself closer to the entrance, next to the platform, to reestablish communications
- Once communications were reestablished, the apprentice began to hoist the platform. The load shifted and swung into the apprentice, crushing his pinky finger between a 2x4 mounted on the wall and the platform.

The apprentice had surgery to repair the broken finger and will remain on light duty for 6 to 8 weeks.

- Unstable wireless communications
- o Not positioned properly in the event of load shift
- o Not using a reliable wired control device

- Always follow the company safety policy
- Always perform a JHA/JSA as per company policy
- Always stay clear of the load when hoisting
