# IUEC INCIDENT SUMMARY

CLOSE CALLS & INJURIES

INJURY

OCTOBER 16, 2024

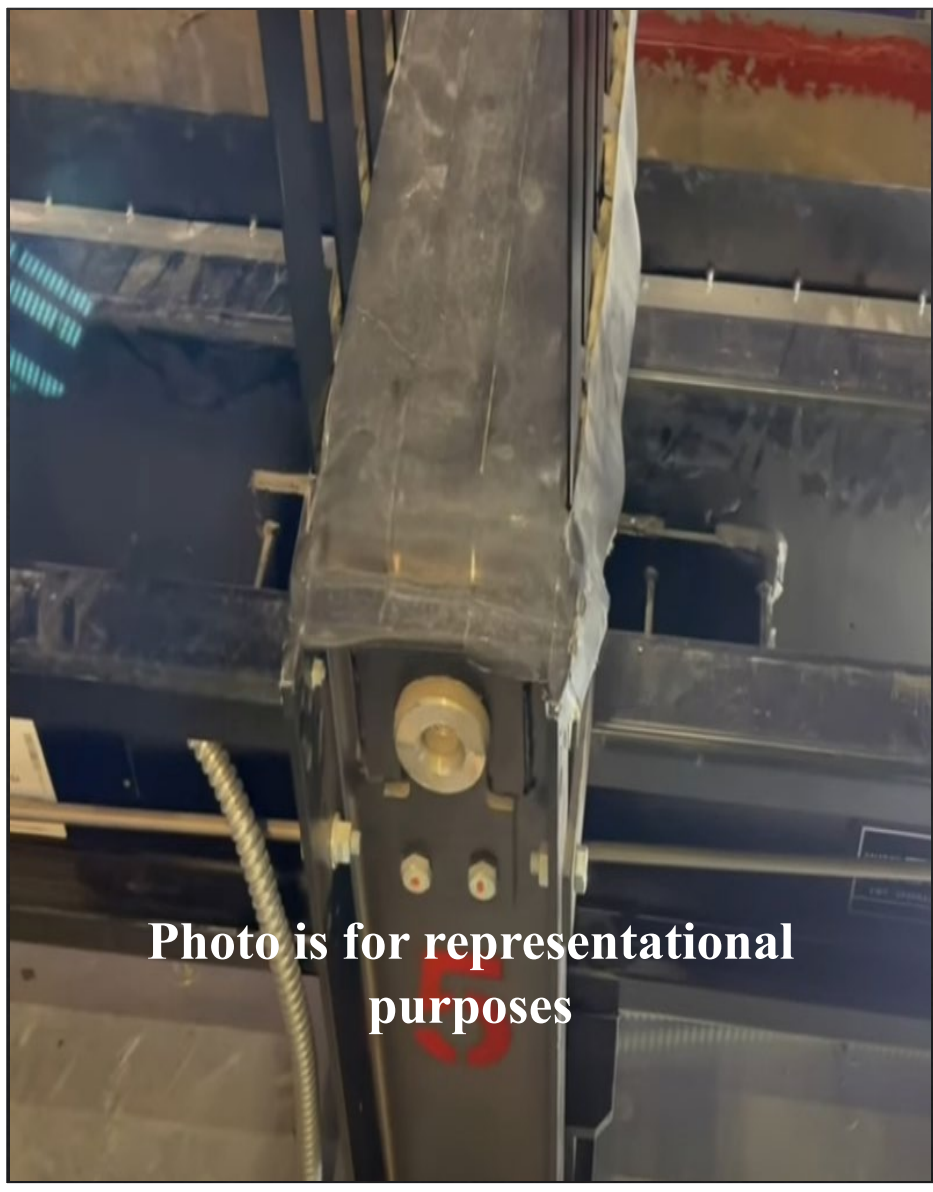
**Photo is for representational purposes**

- A mechanic and an apprentice removed the guard from the car top sheave to inspect the sheave and check tensioning of the CSBs
- During their inspection, the mechanic instructed the apprentice to run the car in the up direction
- The mechanic did not consider the placement of his hand and when the car ran up, his fingers were pulled in between the belts and the sheave
- The apprentice ran the car back down, freeing the mechanic's fingers
- An ambulance was called, and the mechanic was transported to a local hospital

The mechanic received 12 stitches to his fingers and will be out of work for 4 to 6 weeks

- Always follow the company safety policy
- Always perform a JHA/JSA as per company policy

- Replace guards immediately following the work that was performed whenever possible
- Verify everyone is clear (visually and/or verbally) before beginning movement of the elevator

- (b) If movement of the car is needed while on top of the car, be sure to have a firm hold on the crosshead, or other part of the car structure.
- (d) Never hold onto the ropes, sheaves or sheave guard.
