IUEC INCIDENT SUMMARY

CLOSE CALLS & INJURIES

INJURY

JANUARY 14, 2025

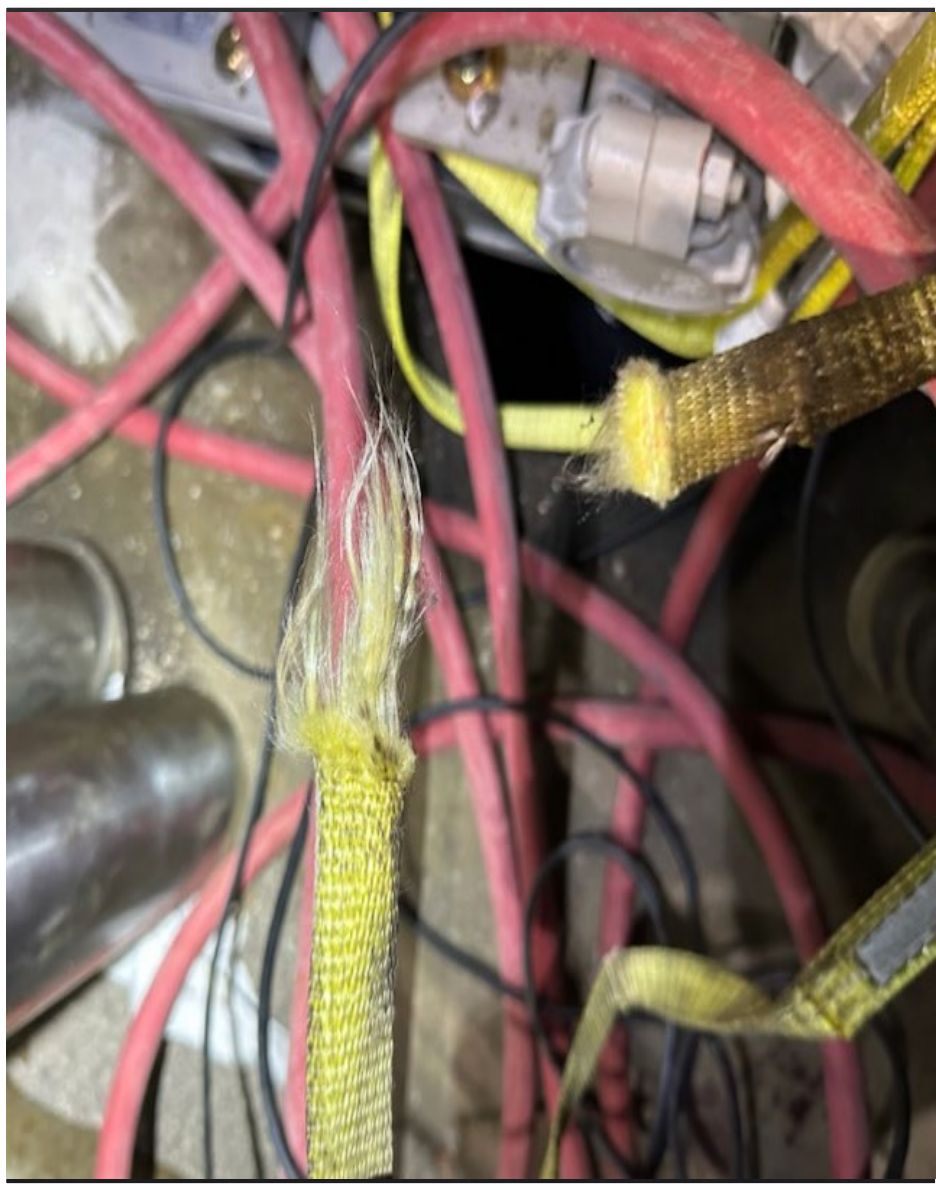
-
- A repair crew was installing a multi piece hydraulic jack
 - The crew was using a nylon strap wrapped multiple times around an overhead beam as a pick point with a snatch block attached and a capstan hoist to lift the load
 - The crew completed assembling the jack and was lifting it to place shim for final alignment when the strap broke. The snatch block fell from the overhead striking the mechanic on the head

The mechanic suffered a fractured C5 vertebrae, received several staples on his scalp and will miss several weeks of work recovering

- Hoisting and rigging equipment not inspected at the start of each day
- Insufficient padding on overhead beam

- Always follow the company safety policy
- Always perform a JHA/JSA as per company policy
- Always wear appropriate Personal Protective Equipment
- Enroll in NEIEP Continuing Education courses for Signaling & Rigging
