TUEC INCIDENT SUMMARY

CLOSE CALLS & INJURIES

INJURY

MAY 27, 2025

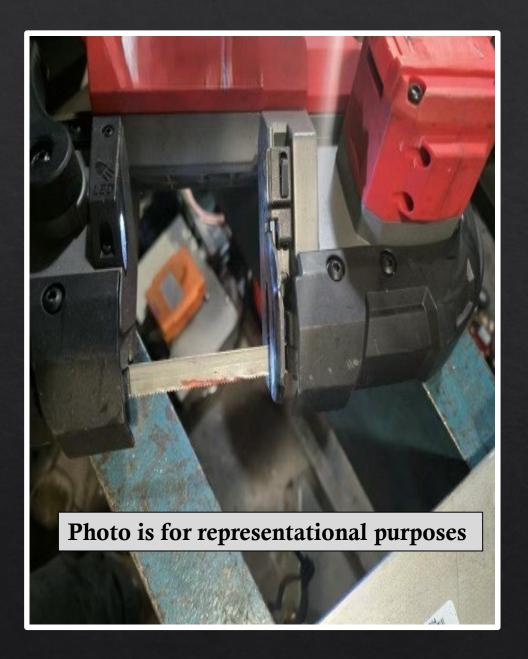
- As he completed the cut, the saw landed on his opposite arm causing a deep laceration
- The apprentice called for help, the mechanic provided first aid, and the apprentice went to the hospital for treatment

The apprentice received 10 stiches

- Always follow the company safety policy
- Always perform a JHA/JSA as per company policy
- Consider using dual-trigger band saws which require two hand operation

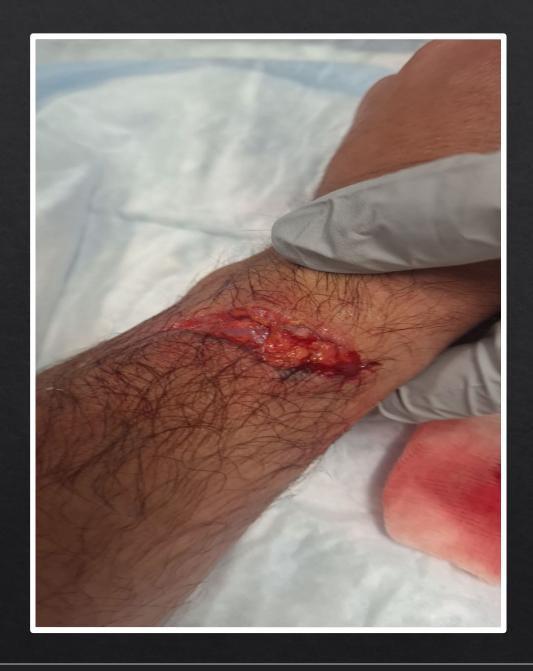
Possible Root Causes:

o Not using two hands while operating power cutting tools
