## OSHA Safety Hazard Information Bulletin on Improper Support of an Elevator Car During Installation

June 22, 1995

SUBJECT: **Hazard Information Bulletin<sup>1</sup>** - Improper Support of an Elevator Car During Installation

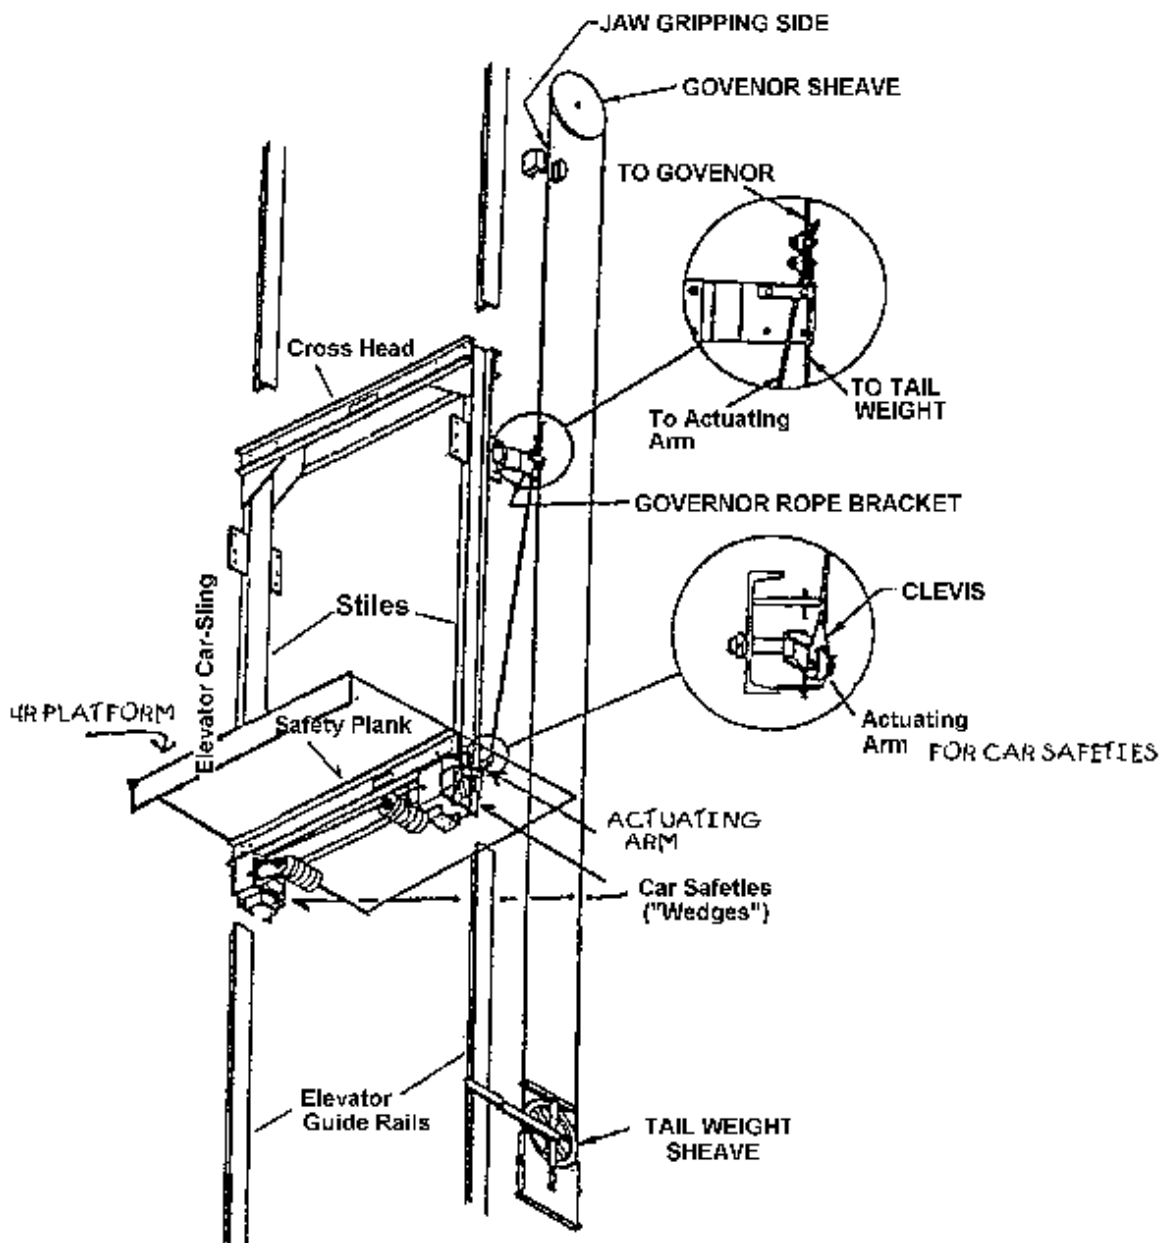
CAR SLING AND PLATFORM OF A TRACTION ELEVATOR  
 DIAGRAM NO. 1

The elevator car can be assembled and then roped at either the top or the bottom of the hoistway. Diagram No. 1 ([see attachment](#)) is an illustration of a roped up governor for a car sling and platform. In some cases, including this incident, the car sling is assembled at the bottom of the hoistway and then is hoisted to the top to be roped. However, in these cases, the car must be positively supported at this level and backup systems must be used to insure that there is no support failure which results in the platform being dropped.

1. The governor must be roped up and the car's safeties (e.g. "wedges" or "safety jaws" which act as rail brakes which grab the elevator's guide rails) made operational prior to hoisting the car sling. In the event of a safety failure (e.g. failure of a support sling(s)) or a drop in the platform the governor is designed to mechanically actuate the car's safeties, which are part of the car sling and platform. When the safeties engage, the car stops prior to falling to the bottom of the shaft, thus preventing a "free fall" of the car sling.

3. When the car sling and platform is raised/hoisted to the top of the shaftway to be roped, it must be positively secured by setting the car's safeties ("wedges") at this elevated level. In addition, one or a combination of the following must be completed: 1) a deck or platform of sufficient strength must be built immediately below the car platform to support the platform in the event of a safety failure; 2) the car sling must be positively secured by placing bolts through the car guide rails so the "safety jaws" rest on these bolts; and 3) from the investigation one other common practice which is not referenced in the training materials is the top member of the car sling (commonly referred to as the "cross head") must be lashed to the rails and/or the division beams using at least one wire rope sling of sufficient strength per rail. To prevent deterioration of the slings, padding or other means of protection must be provided at the points where the slings contact the structural members.
