# IUEC INCIDENT SUMMARY

CLOSE CALLS & INJURIES

INJURY

NOVEMBER 30, 2023

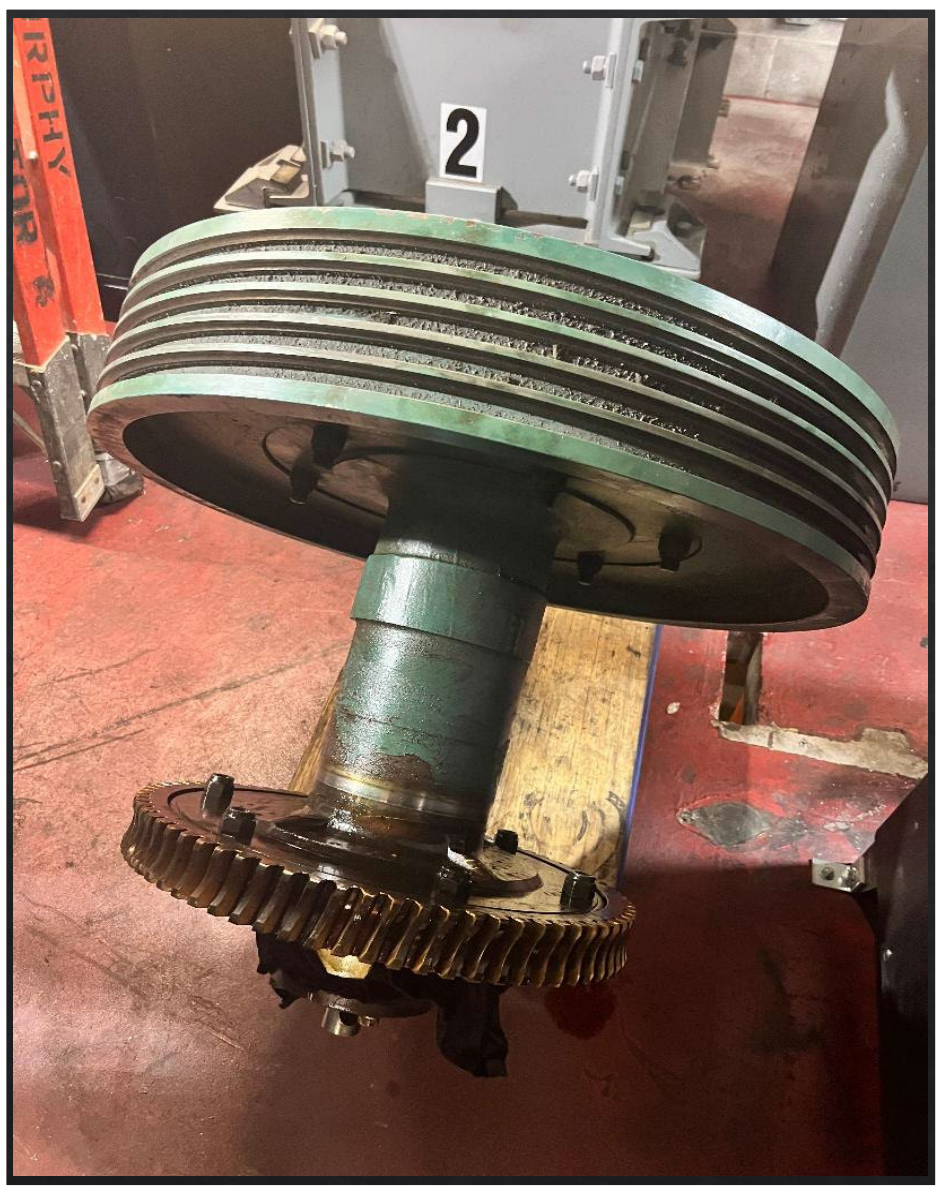
**Warning – Contains Graphic Image**

- 
- Two teams consisting of three mechanics and an apprentice were working on a 6-car modernization job in an office building
  - After the crews discussed their rigging plan, they began removing the old equipment from the machine room
  - They were moving a sheave and ring gear from the machine room to the roof using a chain fall and a strap. One mechanic was holding the back of the sheave when the load shifted and rolled over, catching his hand in the strap and injuring his finger.
  - He went to the ER for x-rays and was administered IV antibiotics and given morphine for pain

The mechanic is healing at home after surgery to repair his hand

- Always follow the company safety policy
- Always perform a JHA/JSA as per company policy

- Verbal rigging plan not adequate
- Not having control of the load
