# IUEC INCIDENT SUMMARY

CLOSE CALLS & INJURIES

SEPTEMBER 24, 2024

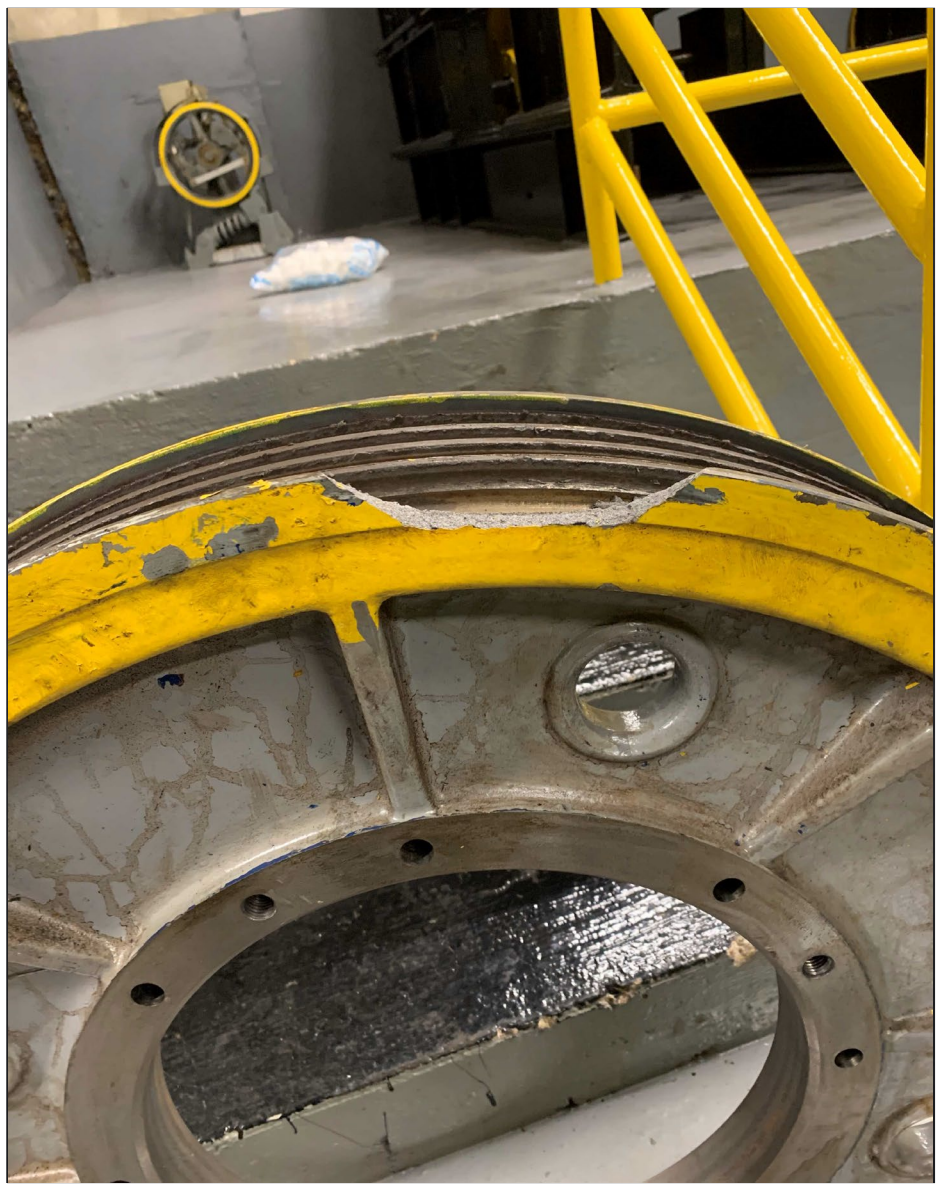
**Warning – Contains Graphic Image**

- 
- A repair crew was removing a drive sheave so it could be replaced
  - During the removal process, a section of outer circumference was fractured off the sheave
  - While the apprentice was trying to roll the sheave to a secure location, he lost control. The sheave fell towards the apprentice, causing him to fall with the sheave landing on his legs
  - The mechanic was able to lift the sheave off the apprentice to free his legs
  - The apprentice was taken to the ER for examination

- Always follow the company safety policy
- Always perform a JHA/JSA as per company policy

- Failure to consider how damage to the sheave would impact movement of the material
- Use teamwork or mechanical advantage for moving heavy loads
- Unstable loads and materials should be secured against tipping or overturning

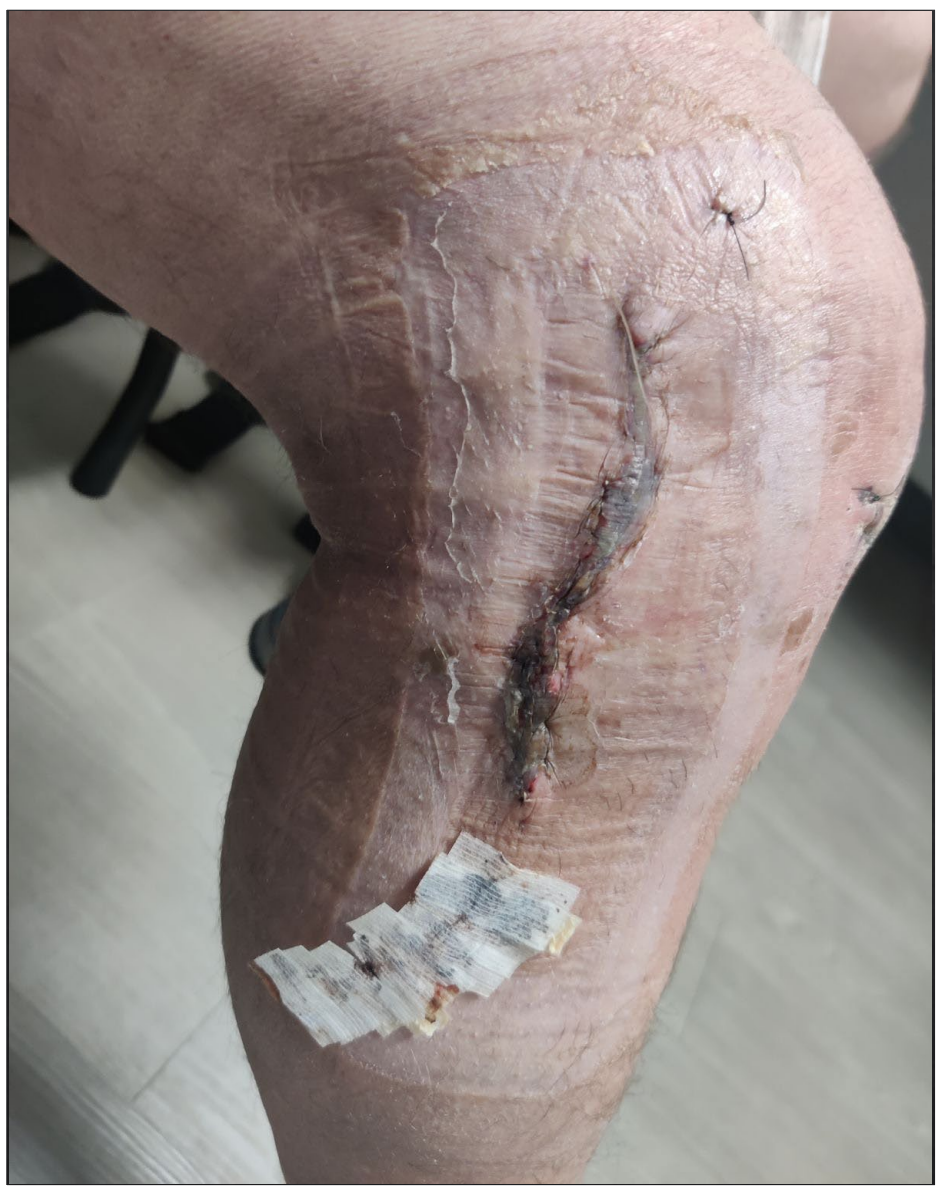
The apprentice suffered a knee injury which required surgery to repair. The apprentice will be out of work for at least three months for recovery.
