# IUEC INCIDENT SUMMARY

CLOSE CALLS & INJURIES

INJURY

OCTOBER 2, 2024

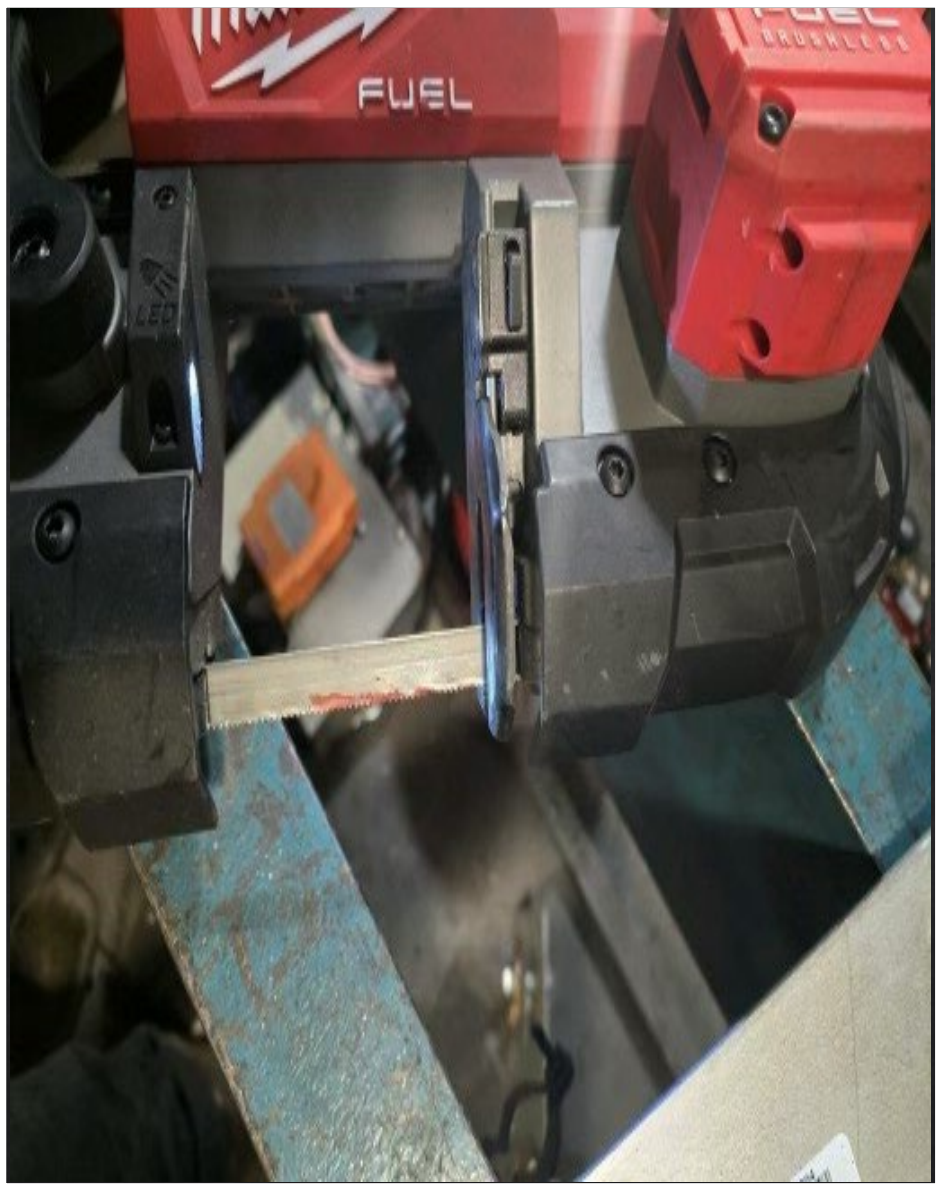
**Warning – Contains Graphic Image**

- An apprentice was cutting a bracket while on the car top during a modernization
- The apprentice clamped one side of the bracket to the crosshead and held the other side with his left hand
- Using one hand to operate the saw, as the cut was completed, he lost control, and the saw landed on his left arm causing a deep laceration

The apprentice was fortunate to only require 7 stitches and was able to return to work performing light duty tasks while the wound healed

- Always follow the company safety policy
- Always perform a JHA/JSA as per company policy
- Consider using dual-trigger band saws which require two hand operation

- Cutting material in a location that does not allow for adequate set up or body position
- Failure to properly secure materials prior to cutting
- Not using two hands while operating power cutting tools
