# SWIVEL SNAPHOOK INSPECTION NOTIFICATION

**Inspection notice for GFP products featuring a possible unsafe condition due to a supplier defect in a specific style of swivel snaphook supplied to Guardian between 8/26/2011 and 6/25/2012**

Date: 6/26/2012

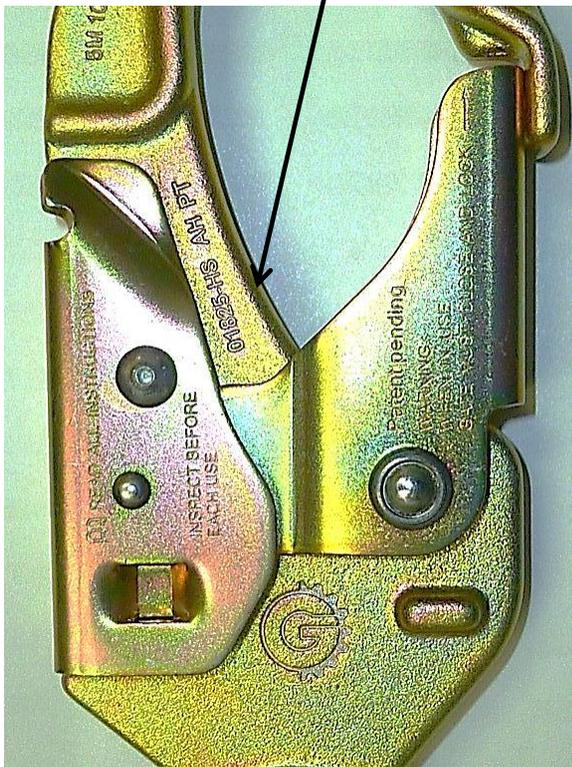
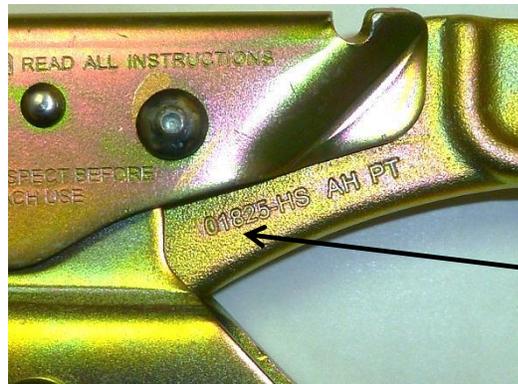
Marked with part # 01825-HS or 01826-HS on the hook body

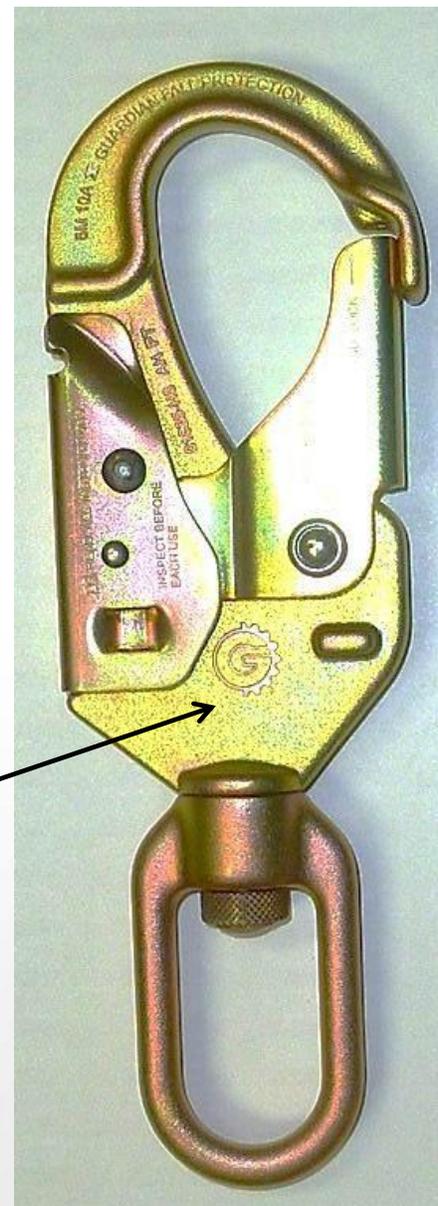
Full photo of the potentially defective swivel snaphook.

Marked with Guardian logo at hook base

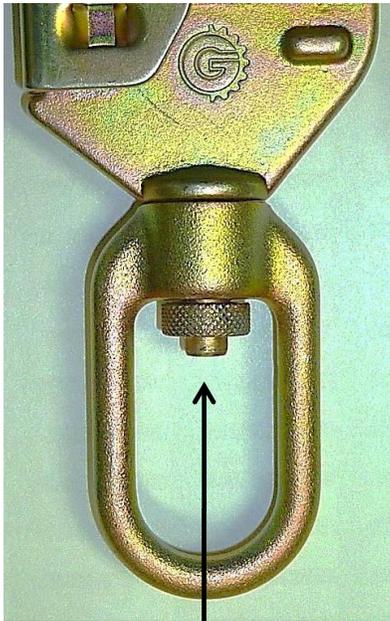
DEFECTIVE CONDITION

The potentially dangerous and faulty condition was caused when GFP's supplier of a particular swivel snaphook missed a swaging operation that encapsulates the swivel eye and prevents the threaded nut from backing off of the hook stem. This situation is restricted to a certain type of swivel snaphook supplied to GFP and is identified in this notice. Upon discovery, both GFP and the supplier have increased inspection processes to ensure this cannot occur in the future. Supplier and GFP inventories have been inspected for this condition upon discovery. **No defective units were found in inventory.** Any products you receive after June 26<sup>th</sup> have been 100% inspected specifically for this condition and any other defect.

BAD HOOK. STEM PROTRUDES STRAIGHT THROUGH THE NUT. STEM HAS NO MUSHROOM SHAPE FLARED OVER THE NUT. NUT CAN BACK OFF THREADED STEM.

Remove the product from service immediately.

Contact Customer Service at GFP (800-466-6385) to be assigned a unique RQC- return number. Guardian will provide shipping instructions for returning products and coordinating replacements for units that have the defective swivel snaphooks. Guardian will replace the product and cover the freight costs.

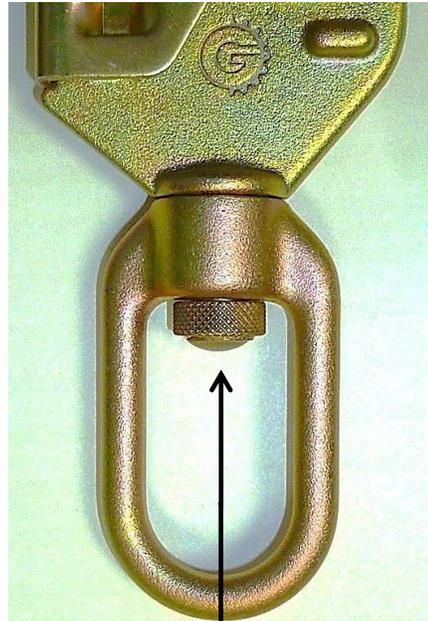
NORMAL CONDITION

NORMAL SWAGED HOOK. GOOD HOOK. STEM FLATTENED IN A MUSHROOM SHAPE. ANY SORT OF SWAGE MEANS HOOK IS GOOD. NUT CANNOT BACK OFF STEM.

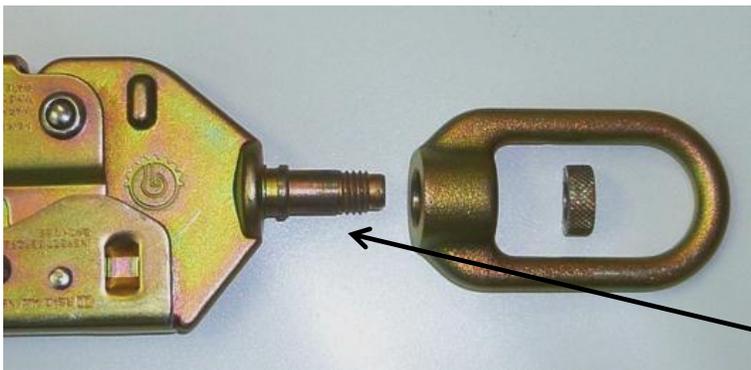
BAD HOOK. STEM OF HOOK BODY WAS NOT SWAGED OVER NUT. THREADED NUT IS CAPABLE OF SPINNING OFF THE STEM.
