NAA Safety Alert

To: Managing Directors, General Managers, and Regional Managers **Subject:** New Access Alert top-of-car inspection station GFCI outlet

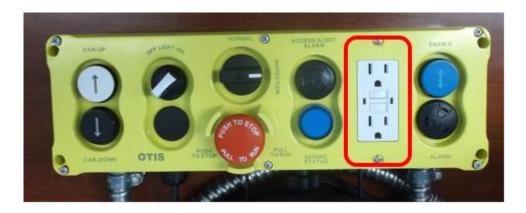
On a recent construction job, an adjustor found the wiring polarity reversed on the GFCI outlet in the new Access Alert top-of-car inspection (TOCI) station. The hot and neutral wires were swapped. The issue was identified when the adjustor was verifying that the voltage 'sniffer' was working to a known source.

Further review at the Florence factory identified that the new Access Alert TOCI stations received from the supplier had the hot and neutral wires to the GFCI outlet wired incorrectly.

The GFCI will function; it will open both hot and neutral sides and the internal test button will trip the GFCI. However, the hot and neutral will be reversed on connections to the outlet and voltage may be present where none is expected. An external polarity tester may not trip the GFCI.
