Important Safety Notice regarding Fluke 8x V Series Digital Multi-meters

ISSUE DESCRIPTION:

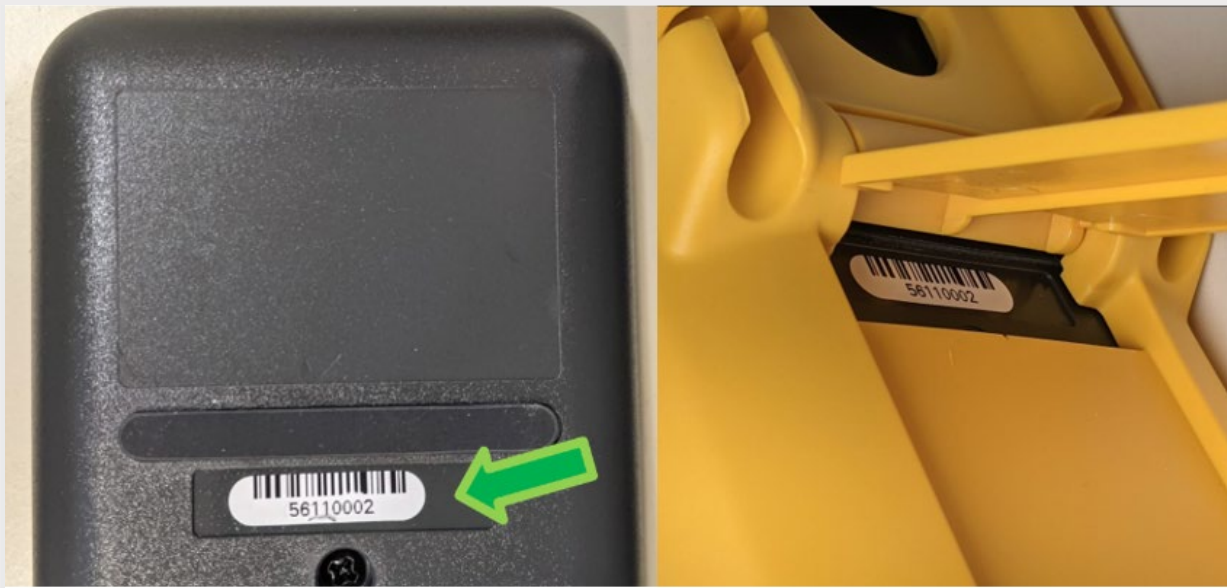
A. Identify your product serial number

If you cannot locate the serial number on your Fluke 8x V series DMM, or if the serial number is illegible, please follow the actions indicated in this Safety Notice in paragraphs B and C below.

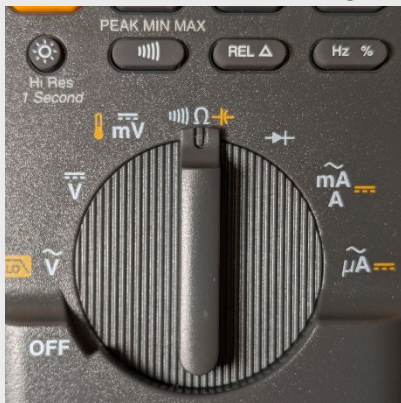
1. Set the meter to Ohms Ω .

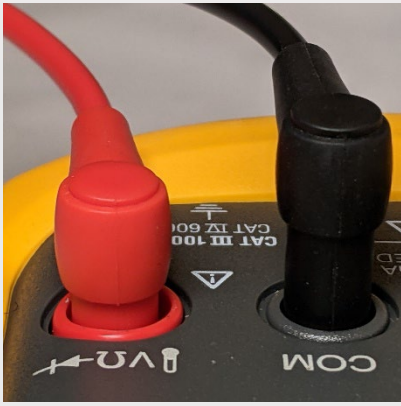
3. Install the red test lead, fully inserting it, while leaving the black lead elevated.

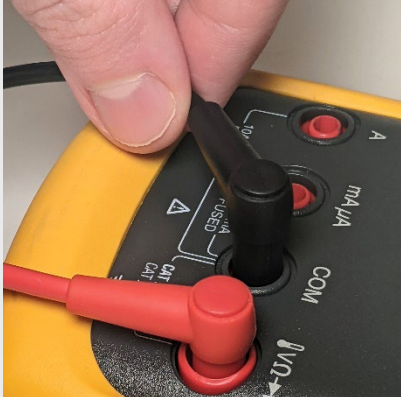
5. Grab the black test lead by the wire and slowly rotate the test lead plug in the COM jack fully in both directions, without pushing it into the jack. Observe the reading on the display as you rotate the test lead plug.

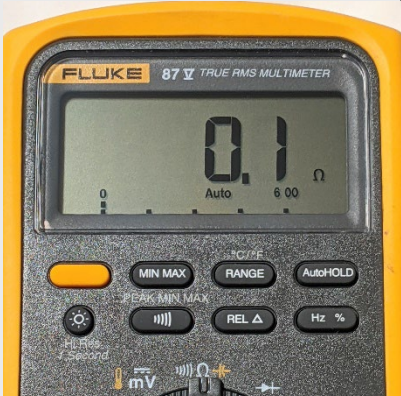
a. If performing properly, the meter will continuously read below 0.5 Ohms. If performing properly, no further action is needed, as your unit is not impacted.

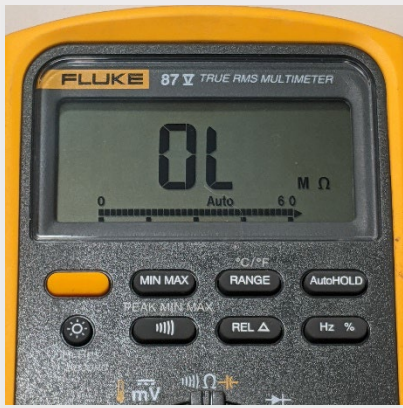
b. If the reading on the display is OL in Ohms or above 0.5 Ohms, please stop using your meter and follow the instructions below to arrange for your meter to be serviced.

If you have identified an issue with your meter using the test above, please [register](#) your 'Affected Product' for service via the registration link below.

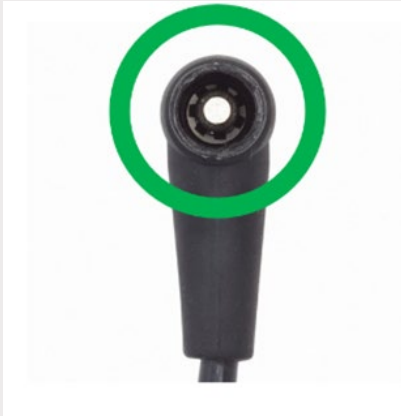
"Lantern spring" style test lead

The Fluke "lantern spring" style test leads² fully inserted have been shown to maintain sufficient contact to prevent the identified potential safety issue. Therefore, if your meter requires service for this issue, but cannot be sent in immediately, the meter may continue to be used with Fluke "lantern

spring” style test leads until the unit can be serviced. See images. All other safety requirements for the use of your DMM and test leads of course remain applicable.

²All Fluke TL75 and TL175 test leads sold separately as accessories are “lantern spring” style test leads.

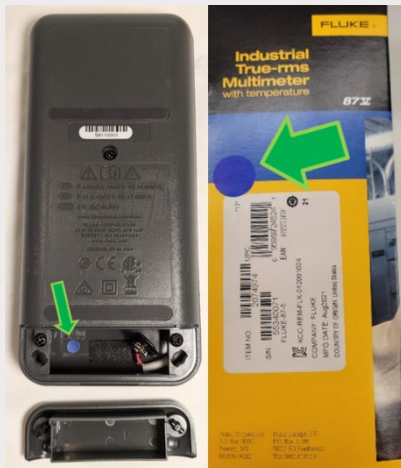
Units in the defined serial number range that had the issue corrected prior to shipment or through service can be identified by a blue or green sticker in the battery compartment and on the unit packaging:
