# IUEC INCIDENT SUMMARY

CLOSE CALLS - INJURY

“INJURY-CAUGHT BETWEEN”

April 28<sup>th</sup> 2023---IUEC Safety Stand Down Day

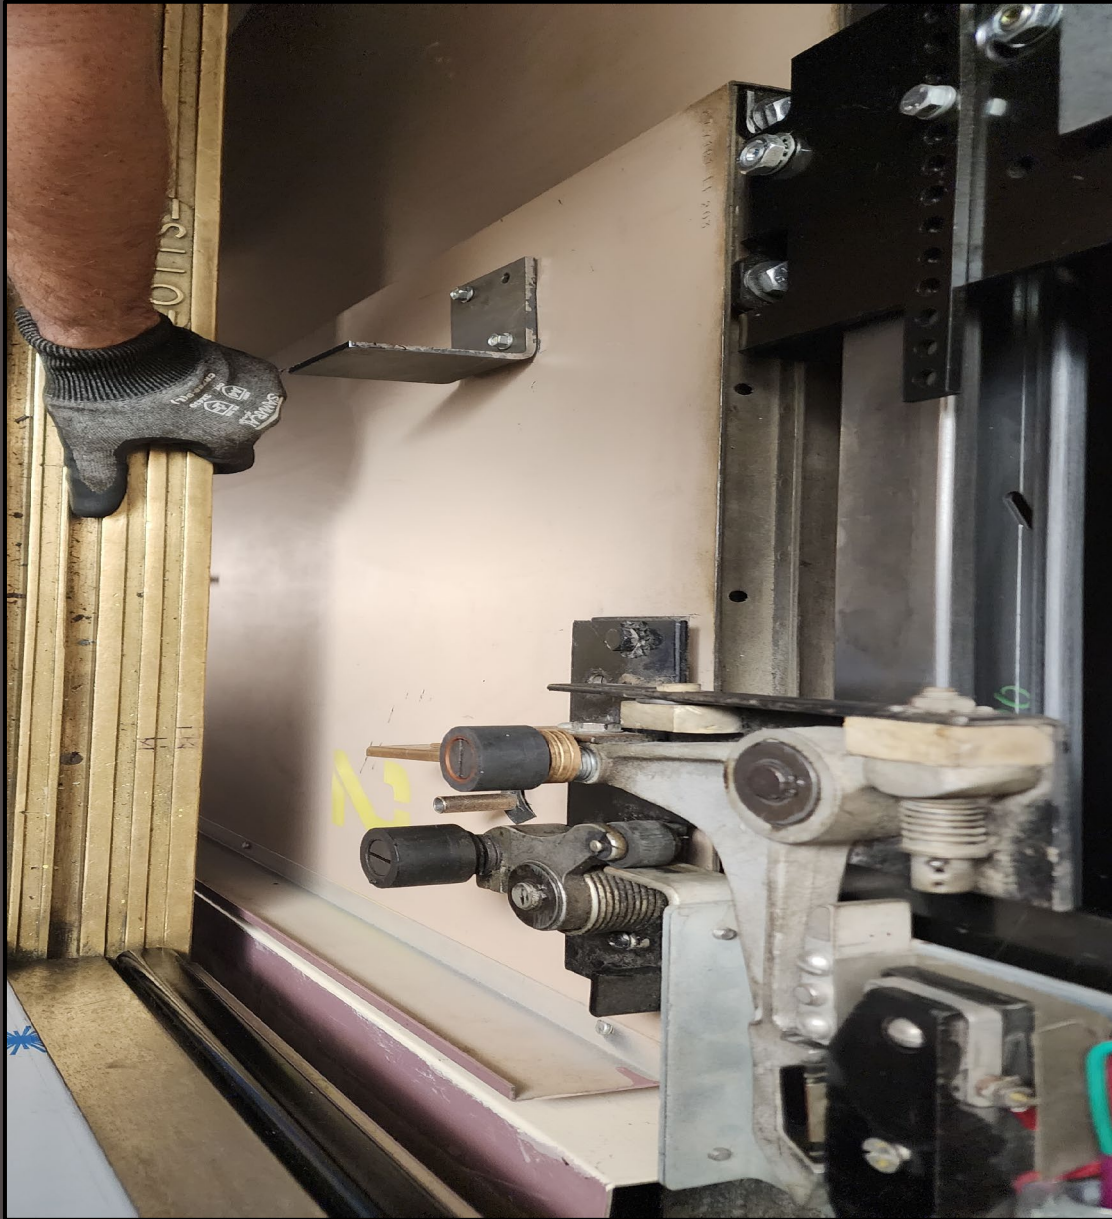
- Two mechanics were working on a modernization job
- One of the mechanics was working on the car top while the other was inside the elevator setting pickup roller clearances to the car sill.
- While the mechanic inside the car was bumping the car into position with the run buttons, his hand became caught between the car door restrictor angle and the car sill.
- The mechanic was afraid to move the car to free his hand, so he had the other mechanic come down from the car top with a prybar to release his hand.
- CURRENT STATUS:
  - The mechanic was taken to the emergency room and received stitches to mend his hand. There were no fractures or tendon damage and when his wounds heal, he will need rehab. He is currently working on light duty.

- Always follow the company safety policy
- Always perform a JHA/JSA as per company policy
- Always follow the MCP and or SOP
- Possible Root Causes:
  - The mechanic was operating the run station with one hand which is against the company safety policy.
  - Fatigue - Both mechanics stated they were tired due to a three-hour commute, working a twelve-hour shift the previous day and a lack of sleep due to a noisy hotel.
- Field Employees' Safety Handbook
- Section 11 Moving Work Platforms
  - 11.1 Running Platforms
  - (f) Temporary run controls shall be three button control ("UP," "DOWN," "SAFETY") so that it takes activation of two buttons to run any direction, plus an emergency stop switch on a stand-alone circuit. Cords shall be fitted with strain relief and insulation shall be intact. All buttons shall function as intended.
