# IUEC INCIDENT SUMMARY

CLOSE CALLS, NEAR MISSES AND INJURIES

07/07/2023 INJURY

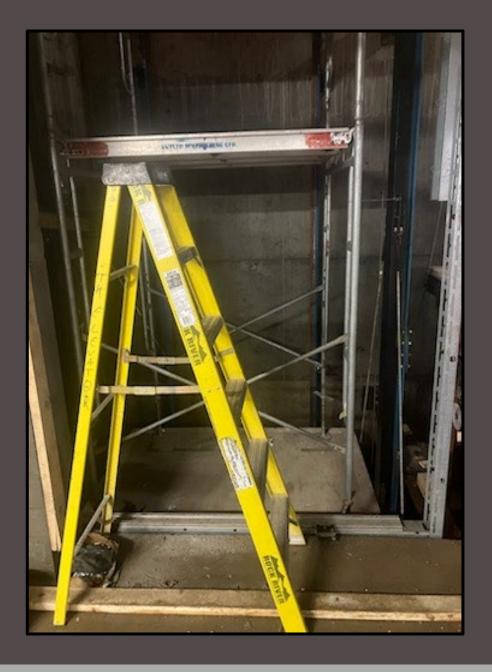
- The car platform was set 2 feet below the bottom landing with scaffolding on the platform. The scaffold working platform was set at approximately 8 feet to access the crosshead sheave
- The mechanic was using a step ladder at the landing to reach tools on the scaffold platform. While standing on the second rung of the ladder, the mechanic reached over to retrieve the tools when the ladder slipped and fell into the hoistway
- The mechanics leg became stuck in the scaffolding brace, and he fell forward dislocating his knee. The mechanic landed on the car platform approximately 4 feet below

- Always follow the company safety policy
- •Always perform a JHA/JSA per company policy

The lateral weight shift applied to the ladder when the mechanic reached to pick up tools from the scaffold platform

The concrete floor at the bottom landing was wet
