IUEC INCIDENT SUMMARY

CLOSE CALLS & INJURIES

INJURY

FEBRUARY 2, 2024

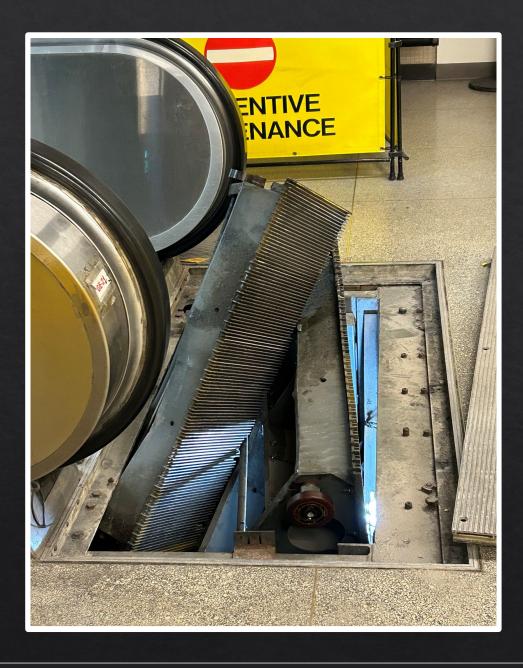
- While the mechanic was removing the first step it didn't line up with the crab track, so he pushed the step back in and attempted to jog the unit to have it line up
- When he jogged the unit, the escalator started to run on automatic and the steps began to pile up while he was still in the well
- The mechanic was able to free himself and was taken to the hospital via ambulance

The mechanic had surgery to repair his fractured foot and is hopeful to return to work in 4-6 months

- Always follow the company safety policy
- Always perform a JHA/JSA as per company policy
- Always follow the MCP
- Never stand in the truss or pit while moving an escalator

- Lack of a pendant station for inspection operation
- Lack of a Standard Work Practice for step removal

(n) Where possible, do not "inch" equipment unless the holding circuit has been opened.
