# IUEC INCIDENT SUMMARY

CLOSE CALLS & INJURIES

INJURY

FEBRUARY 9, 2024

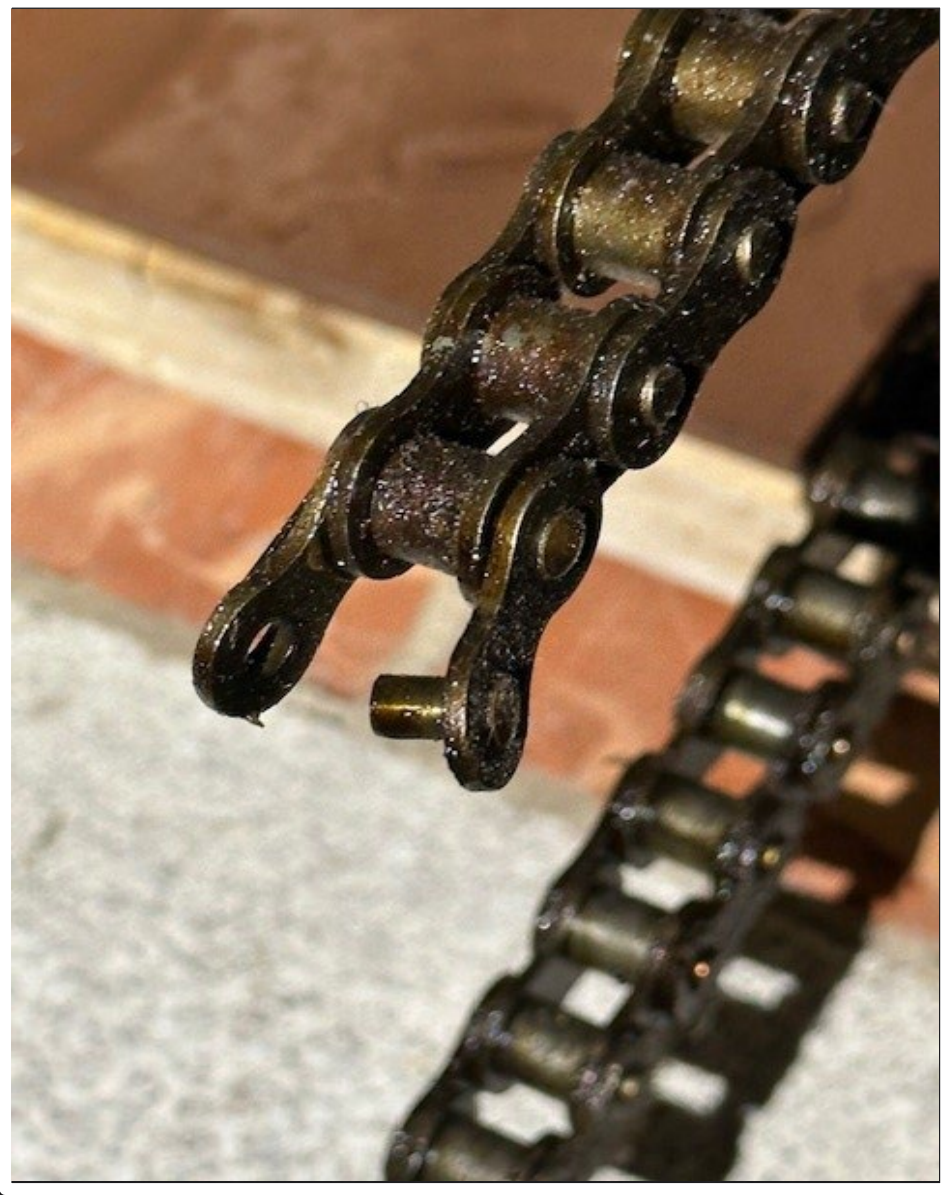
- A repair team was repairing a broken chain link on the suspension means on a residential lift.
- The link they replaced was on the counterweight side. After completion of the repair, they sent the car on automatic from the bottom floor to the top of the three stop hoistway, and the car ran with no issues.

- The mechanic instructed the apprentice to ride the car to verify operation. On the first trip down the apprentice felt a slight jerk and he opened the gate stopping the car between floors. It was noticed there was a small amount of slack on the car side chain.

- The mechanic bumped the car up to remove the slack with the apprentice still inside the car. As soon as the car moved, the chains on the car side broke loose and the car crashed into the pit.

- Upon investigation, slide marks on the rails were discovered but the safeties did not stop the car. The pit is only 4 inches deep and the car with the apprentice inside crashed onto the pit floor.

- Always follow the company safety policy
- Always perform a JHA/JSA as per company policy
- Always follow the (MCP) Maintenance Control Program
- When no onsite documentation is available due to age of equipment, guidance can be found in ASME A17.2.
  - Item 2.21 Chain-Drive Machines
  - Item 2.29 Car and Counterweight Safeties

- Excessive wear on the master link that connects the chain to the car-side hitch
- Lack of experience and training on this type of equipment
- No enforcement of maintenance and testing requirements
