IUEC INCIDENT SUMMARY

CLOSE CALLS & INJURIES

INJURY

JUNE 12, 2024

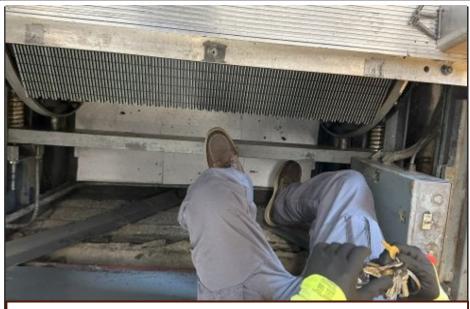
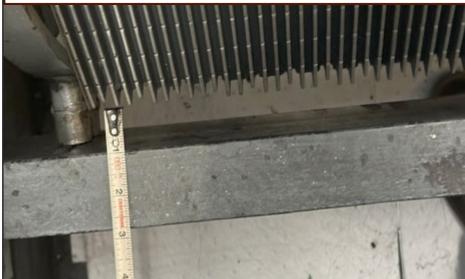
- Prior to going to lunch, the apprentice used the key switch to run the unit to cover the hole left by the removed pallets
- The apprentice was sitting on the edge of the truss with one foot in the pit and the other foot resting on a cross brace
- The apprentice ran the unit towards himself forgetting about the pallet hidden under the combplate. The pallet came around the step turnaround where there was only 1 inch of clearance between the pallet and the cross brace. The pallet caught his left foot tearing the top of his boot off and degloving the top of his foot.

The apprentice's foot is severely damaged. He is in the healing process and the extent of permanent damage is yet to be determined.

- Always follow the company safety policy
- Always perform a JHA/JSA as per company policy

- Lack of Standard Work Processes
- o Lack of training
- o Failure to address known hazards during the JHA
