# IUEC INCIDENT SUMMARY

CLOSE CALLS & INJURIES

NOVEMBER 26, 2024

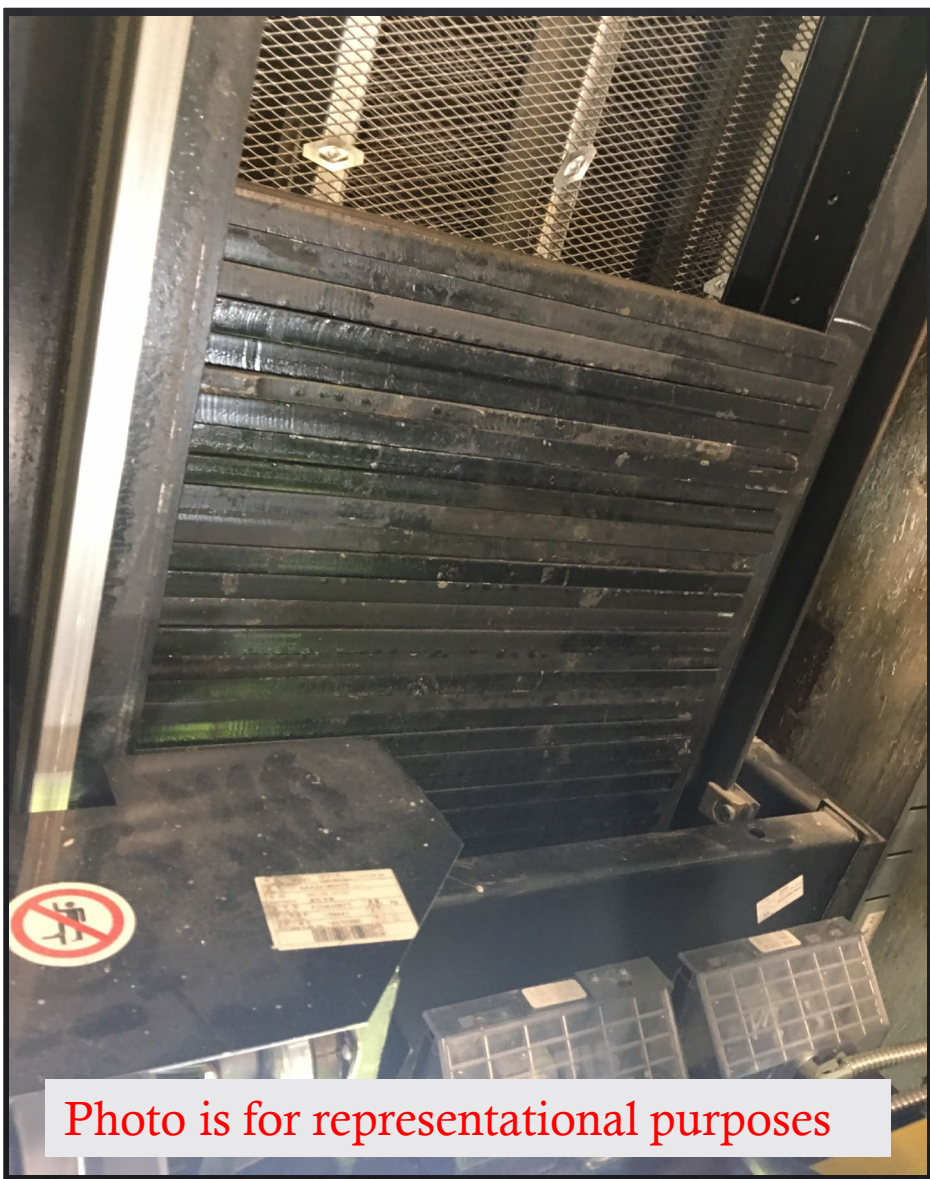
- A modernization crew was installing filler weights into a counterweight frame by hand from the car top
- The apprentice was adding a weight when his middle finger got pinched between two of the weights

Photo is for representational purposes

- Lack of training on company installation tools and methods
- Proper tools for installation were not provided

- Always follow the company safety policy
- Always perform a JHA/JSA as per company policy
- Always verify and follow company SWPs
- Use a wedge type tool or other device to prevent pinch points
