# TUEC INCIDENT SUMMARY

CLOSE CALLS & INJURIES

**INJURY**

**APRIL 3, 2025**

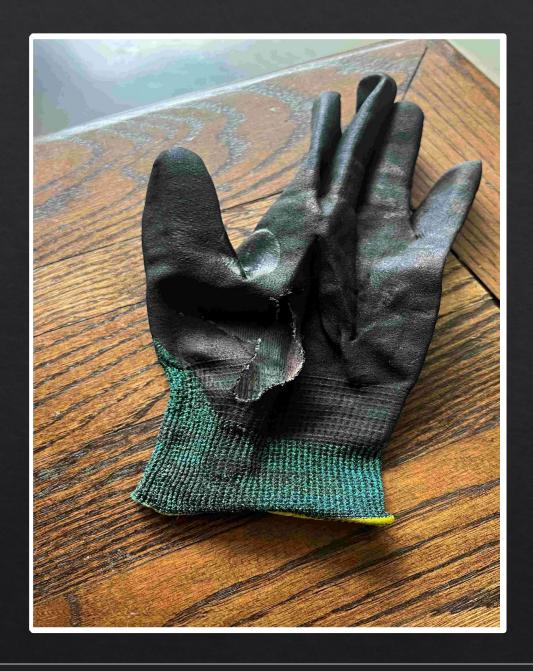
Warning – Contains Graphic Image

- The apprentice had previously only worked with flat traveling cables
- The apprentice was using a utility knife with a hooked blade to remove the traveling cable's jacket
- While making a cut in the outer jacket, the knife slipped, and he pulled the blade into his gloved hand causing a deep laceration

Current Status: The apprentice received 12 stitches

- Always follow the company safety policy
- Always perform a JHA/JSA as per company policy
- Use company approved cable stripping tools

- o Improper hand position while using cutting tools
- Using dull or worn cutting tools
